**IMAGE AND COMPOSITIONAL CHARACTERISTICS OF THE
LDEF "BIG GUY" IMPACT CRATER**

ABSTRACT

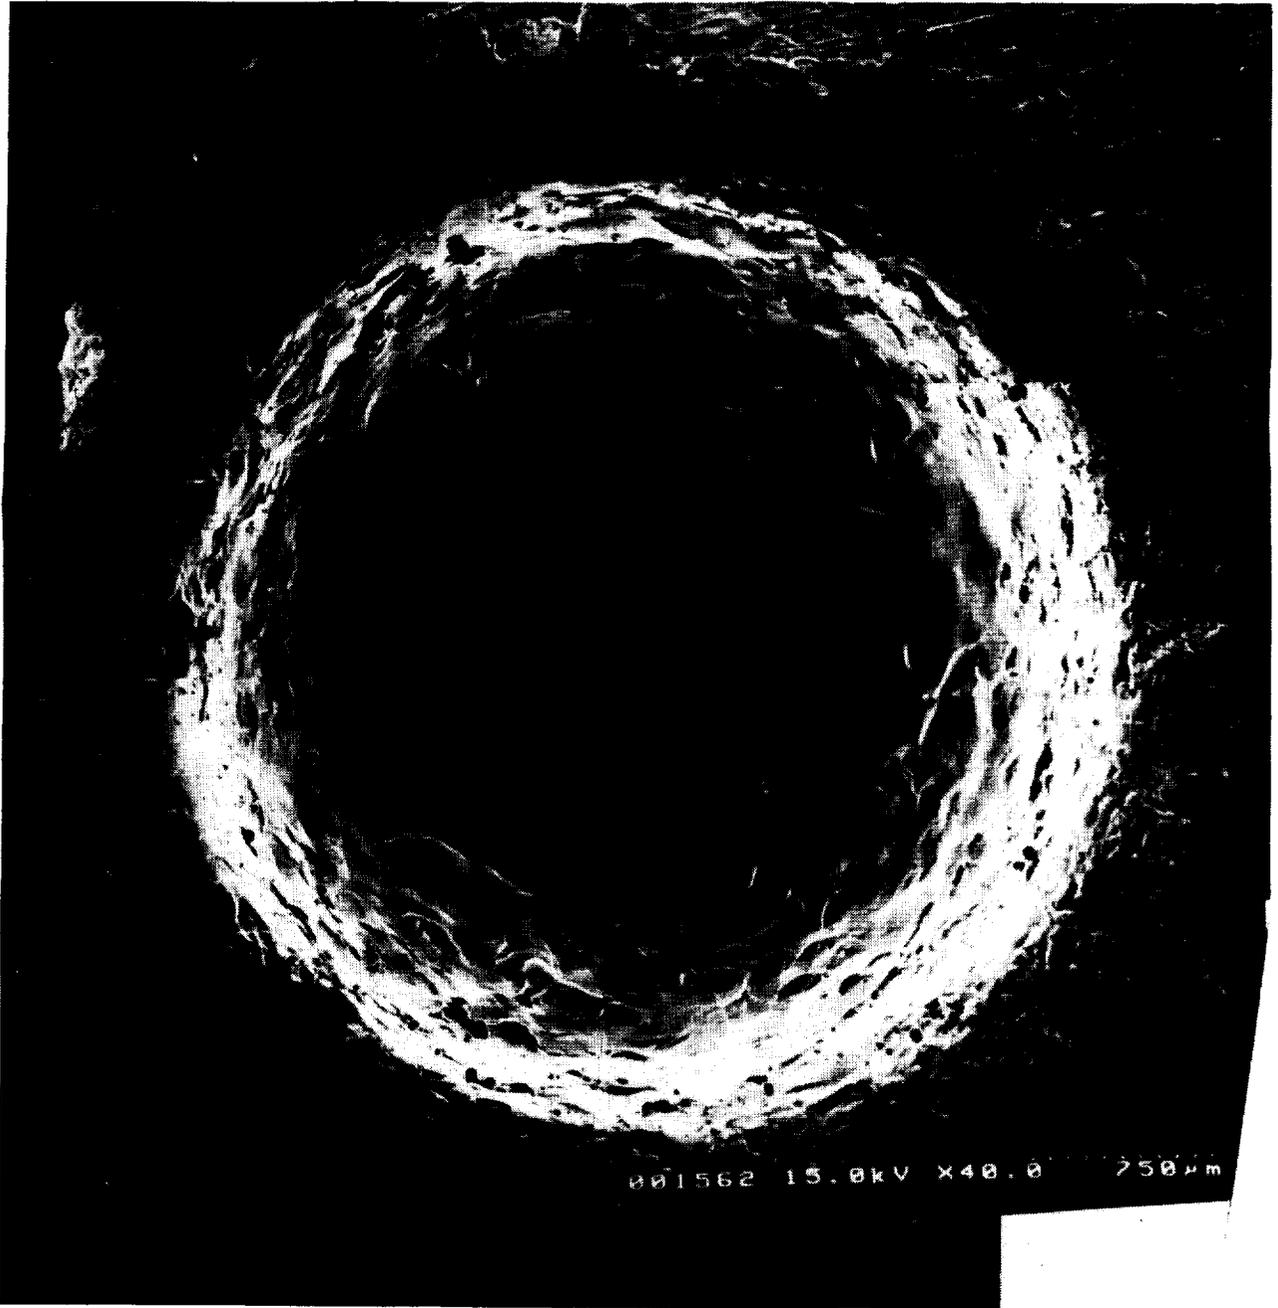
An FESEM image of the crater is shown in Fig. 1. A small amount of melt is visible in the crater bottom with more melt on the upper wall near the rim. In general, the melt liner appears to be quite thin. No intact projectile or dark patches on the rim were found. The only prominent melt-forms are droplet to dome-shaped columns (see Fig. 2). These objects on the rim appear to be darkened on their top surfaces when viewed through the stereo microscope, although this could also be an artifact due to illumination

Figure 1. FESEM imagery mosaic of the Big Guy crater.

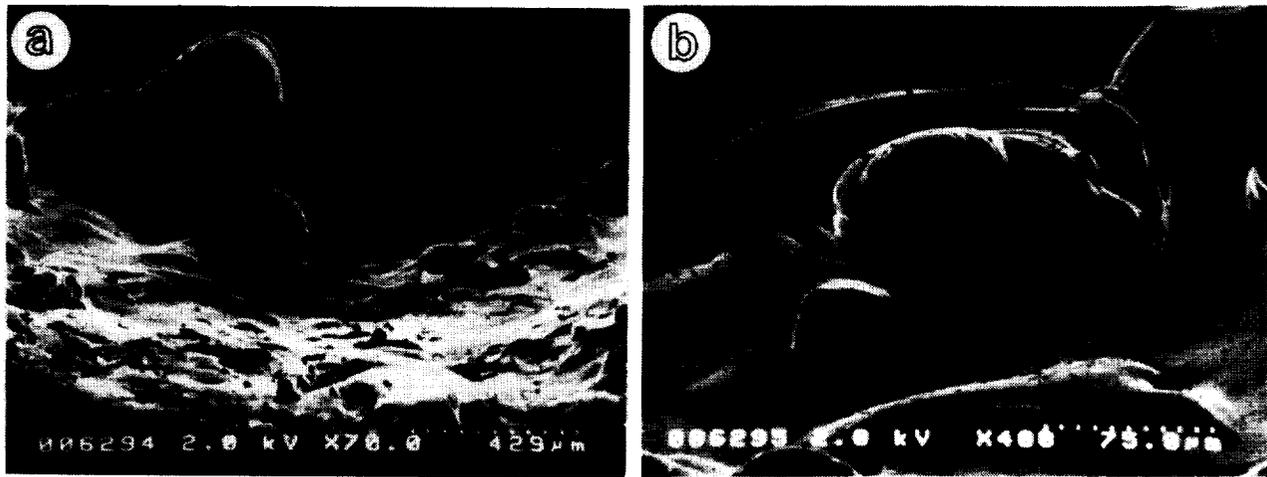
under the microscope. Figure 3a shows an example of the unusual domed objects, with the horizontal layering effect. Figure 3b is an example of a melt form that appears to have collapsed before it completely froze.

Figure 3. FESEM images. (a) Open arrow points to domed object with prominent rings/layers. Solid arrow indicates a melt droplet that collapsed into a "puddle" before solidifying. (b) Enlarged view of collapsed droplet.

Silicon is added to Al to form a harder, somewhat less ductile alloy; enhanced Si content also increases the viscosity of molten Al (ref. 3). The peculiar layered textures of the melt forms may have resulted from differential cooling rates between the higher viscosity melt surface, which we find to be enriched in Si, and the underlying portions that may be less viscous. These textures may also have arisen, in part, from spiral dislocation arrays promoted by non-equilibrium and rapid cooling conditions. We conclude that compositional heterogeneities together with extremely rapid cooling (the crater forming event was very fast, on the order of 10 μsec; ref. 4) probably gave rise to the unusual forms and textures observed in the Big Guy crater.

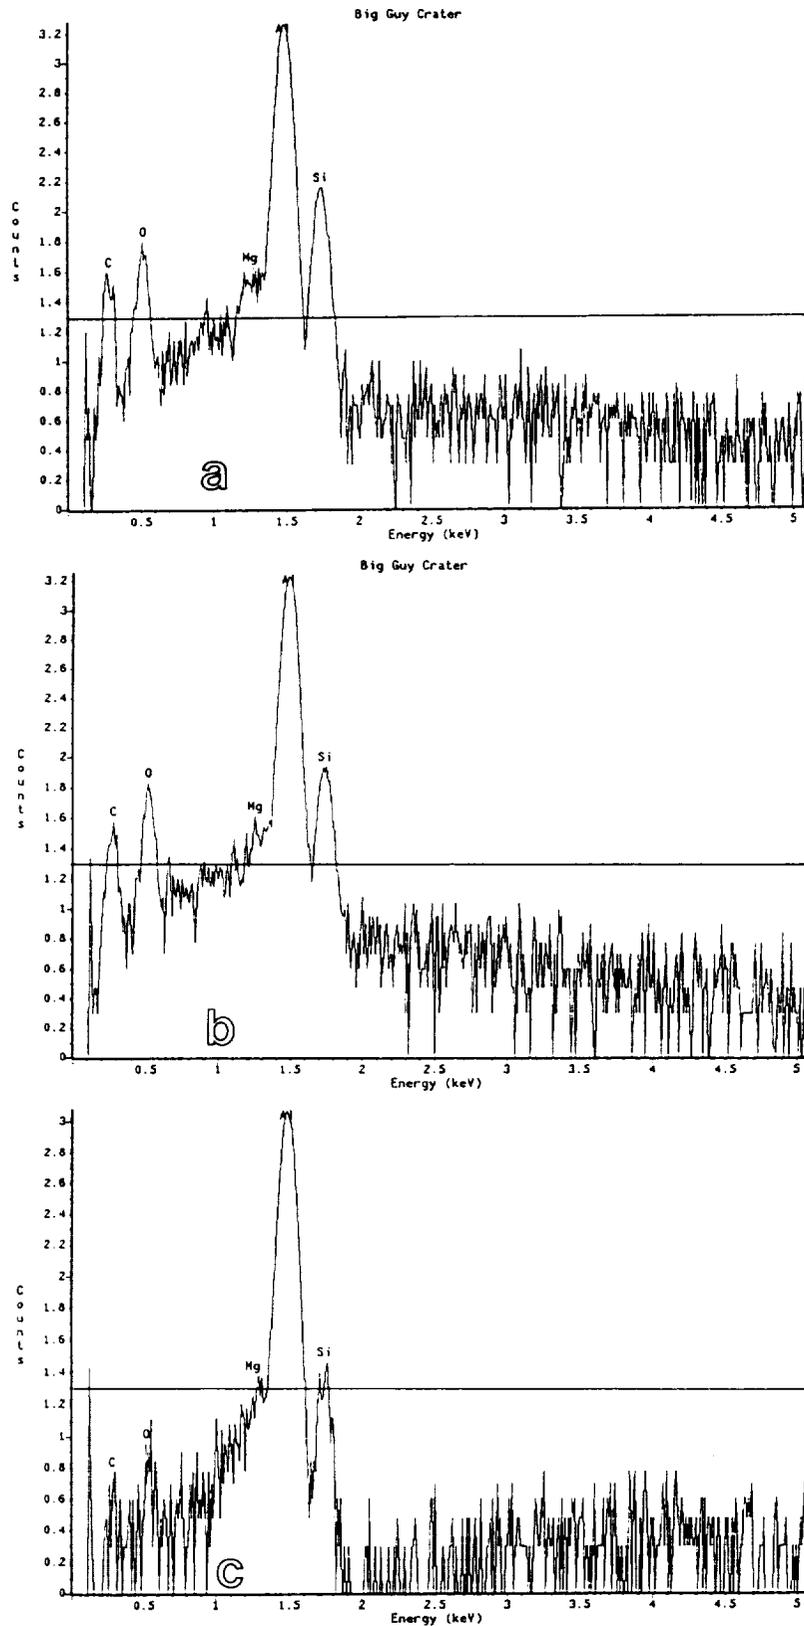
FESEM-EDS analyses of the crater cavity and rim show the presence of Si, Mg, C, and O. The amounts of Si, in particular, vary considerably, depending on the location of the analysis. The top of droplets and dome-shaped columns have the highest amounts of Si, melt liners intermediate amounts and unmelted areas on the rim, the lowest (Fig. 4). The rim analysis also corresponds to an analysis of a point away from the crater that was covered with lexan before it was removed for the crater study. A piece of the frame underside was polished and analyzed by a Cameca electron microprobe. This analysis, and an additional analysis away from the crater in the vicinity of the EDS analysis, show the average Si content to be 0.34 wt % (range, 0.23 to 0.39) and Mg content is 0.94 (range, 0.83 to 1.02). Thus, the EDS spectrum of the point away from the crater is taken to be the background reference composition of uncratered Al. By comparing analyses of melt forms, Si shows an increased content of at least 3-fold or ≈ 1.0 wt %; Mg shows no significant change. The presence of C, intrinsic to the crater, is confirmed by EDS analyses, although some unknown amount is attributed to contamination during analysis. TOF-SIMS analyses indicate, in addition to Si, Mg, C, O, the presence of S, Cl and Na, which are known contaminants of LDEF surfaces.

Figure 4. EDS analyses of droplet top (a), domed columns (b), and melt liner (c). Horizontal line in each indicates intrinsic Si content of Al alloy. The y-axis (counts) uses a logarithmic scale to allow examination of minor elements in the presence of Al.

Analyses of the crater show no chondritic compositional evidence (Si, Mg, Al, Ca, Fe, S, ± Ni) for an extraterrestrial impactor. Silicon and Mg contents are attributed to the intrinsic minor element composition of the 6061 T6 Al plate. Silicon is enriched in the melt liner and melt forms relative to Al away from the crater. The mechanism for increasing Si content in the Al is unknown. Either an enrichment of intrinsic Si occurred during impact melting by some fractionation process or Si was added by an unknown orbital debris impactor. Carbon content is most likely a contaminant that resulted from vaporization of the overlying lexan during impact.
